MATERIALS RESEARCH FOR THE CLEAN UTILIZATION OF COAL

QUARTERLY PROGRESS REPORT

October - December 1979

Center for Materials Science
National Bureau of Standards
Washington, D. C. 20234

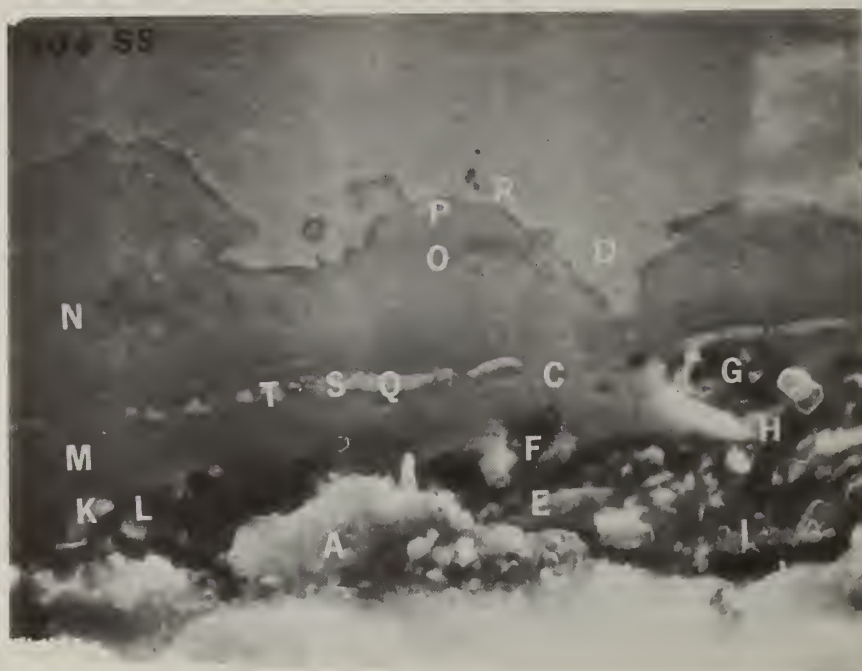
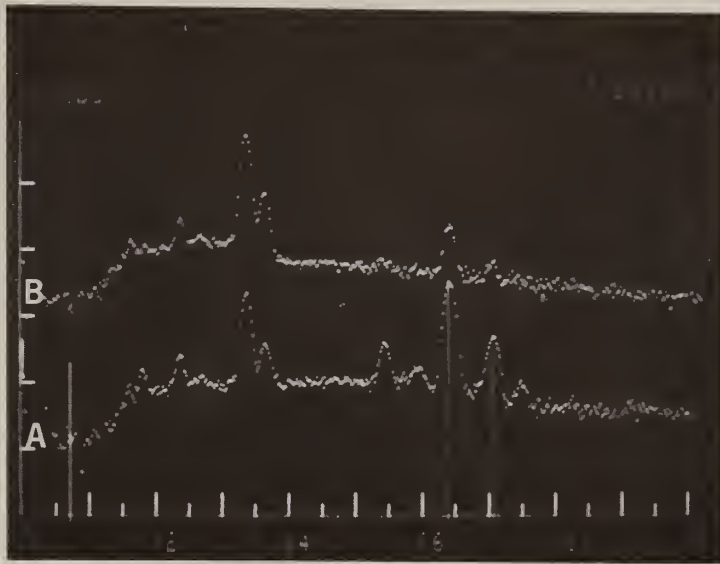
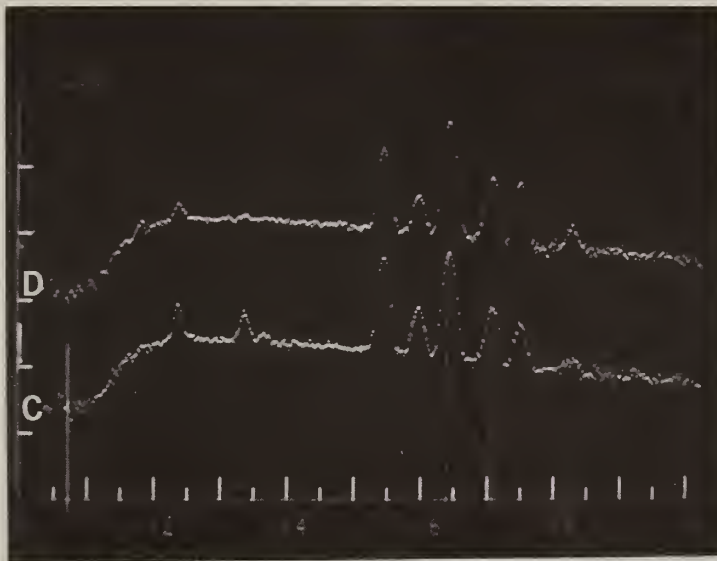
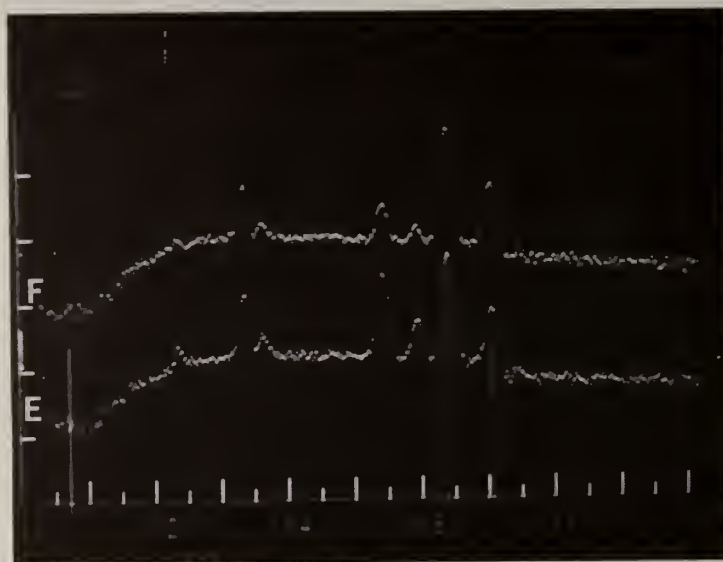
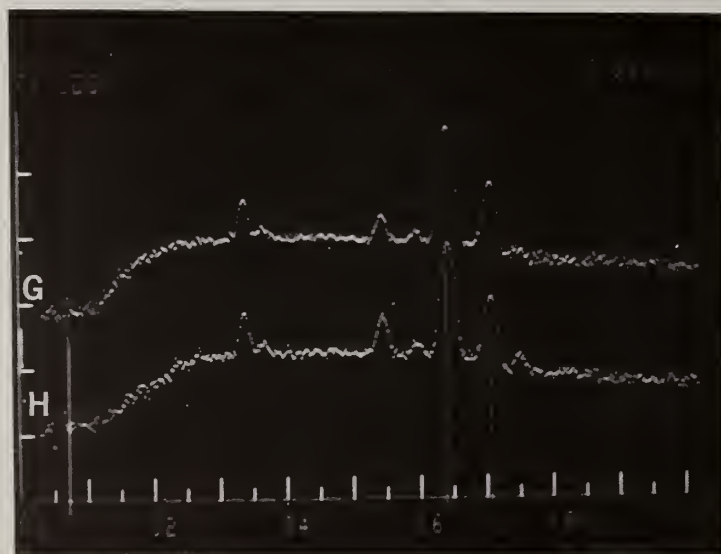
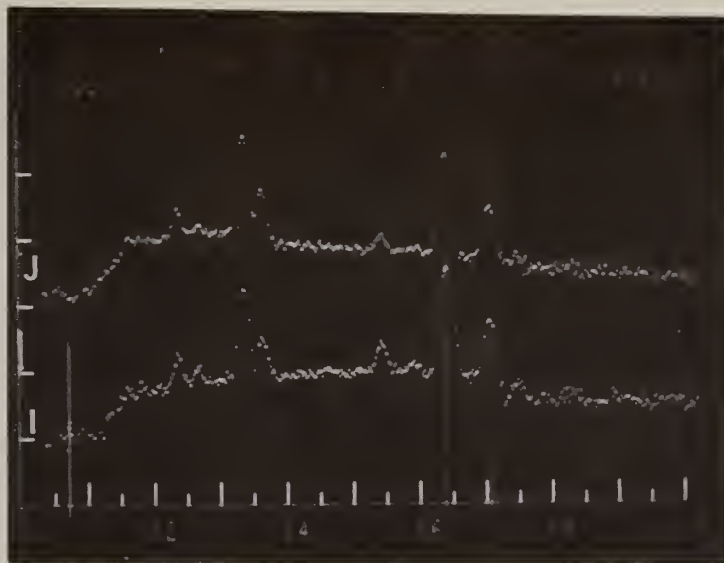
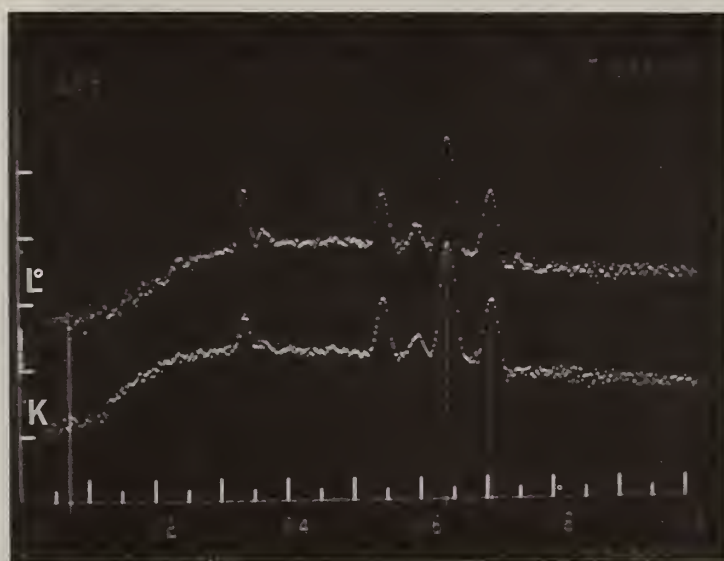
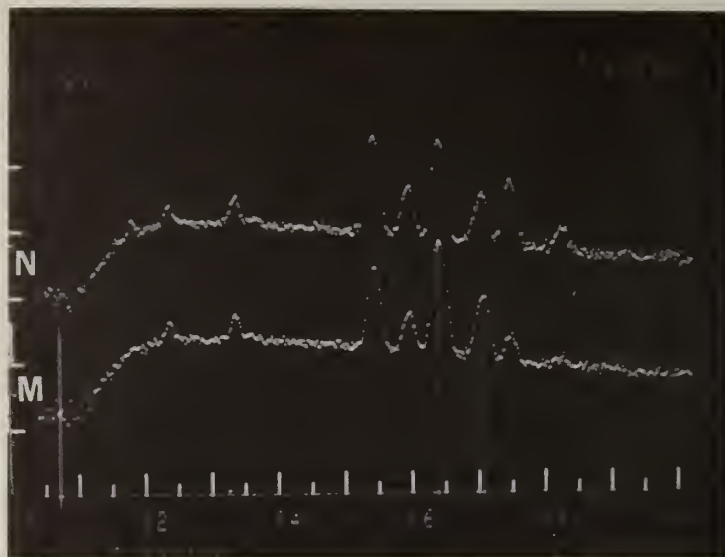
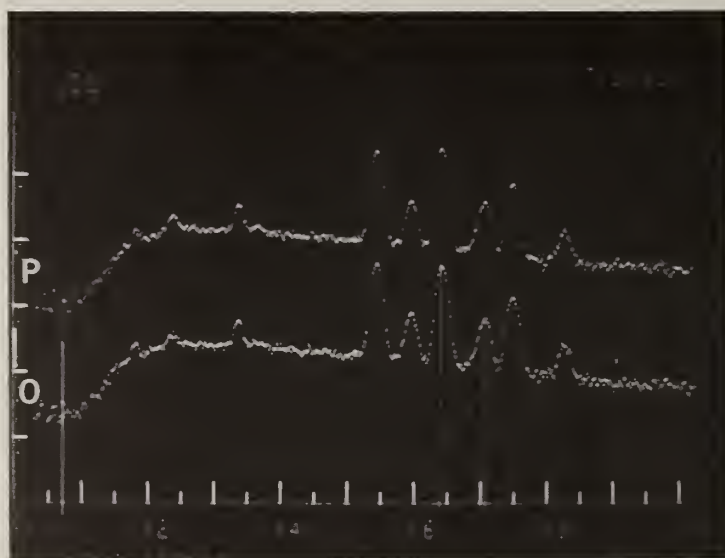
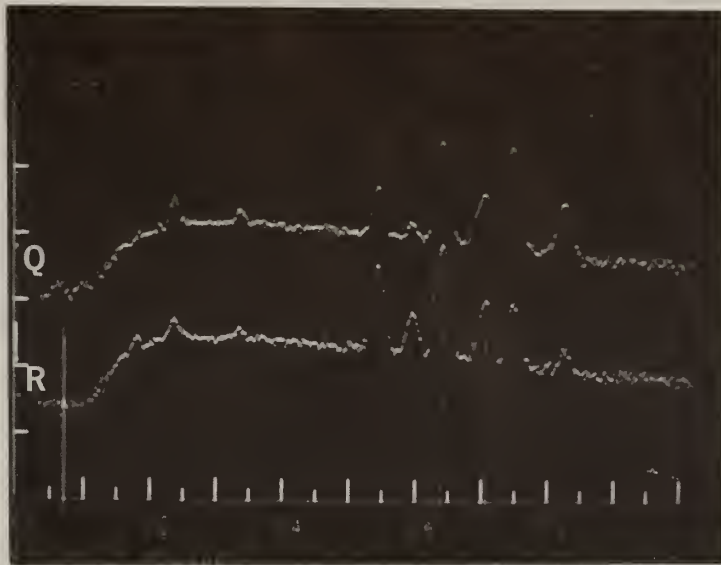
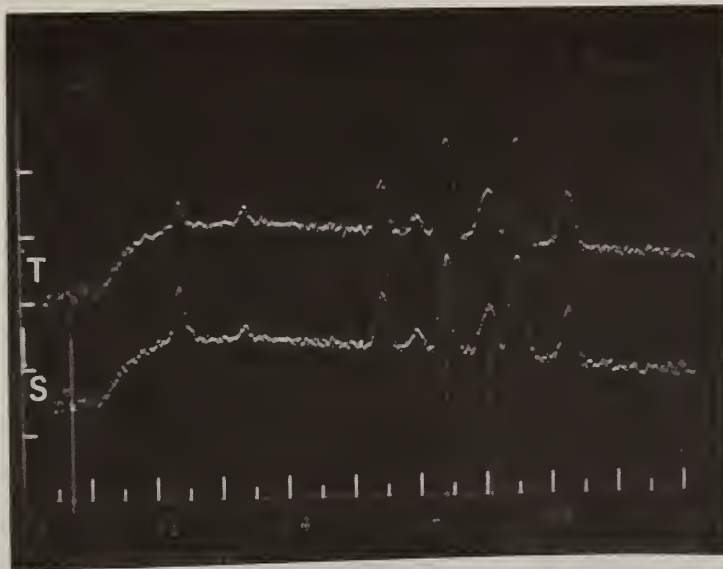
Fig. 8. SEM micrograph, 2000 X, of stainless steel-salt deposit reaction zone. Lettered regions correspond to labeled EDX spectra, Figs. 8a-8j. Specimen temperature 590°C; gas stream oxygen rich.

Fig. 8a. EDX spectra of regions A and B of Fig. 8 showing Fe penetration in the salt deposit.

Fig. 8b. EDX spectra of regions C and D of Fig. 8 showing area of high Cr concentration as compared to bulk stainless.

Fig. 8c. EDX spectra of regions E and F of Fig. 8 showing area of high Cr and high Fe concentration with absence of Ni at the stainless steel-salt interface.

Fig. 8d. EDX spectra of regions G and H of Fig. 8 showing area of high Fe and low Cr concentration with traces of Ni at the stainless steel-salt interface.

Fig. 8e. EDX spectra of regions I and J of Fig. 8 showing penetration of Fe and Cr in the salt deposit.

Fig. 8f. EDX spectra of regions K and L of Fig. 8 showing area of high Fe and low Cr concentration with absence of Ni at the stainless-steel salt interface.

Fig. 8g. EDX spectra of regions M and N of Fig. 8 showing areas of high Cr and high Ni concentration as compared to low Cr and low Ni below the stainless steel-salt deposit interface but within the reaction band.

Fig. 8h. EDX spectra of regions O and P of Fig. 8 showing areas of high Cr and high Ni concentration below the stainless steel-salt deposit interface, but within the reaction band.

Fig. 8i. EDX spectra of regions Q and R of Fig. 8 indicating a region of very high Ni concentration in a matrix of high Cr concentration as compared to the bulk stainless steel.

Fig. 8j. EDX spectra of regions S and T of Fig. 8 showing high Ni concentration with the high Cr concentration matrix.

The corrosion band area on the 304 stainless steel increases with increasing temperature. The variation in corrosion can be observed in the comparison of Figure 7 (specimen temperature 500 °C) with Figure 8) specimen temperature 590 °C). SEM/EDX analysis of both samples, Figures 7a-7g and Figures 8a-8j, indicate metal corrosion and metal cation migration, however, the 590 °C specimen shows the corrosion picture more vividly.

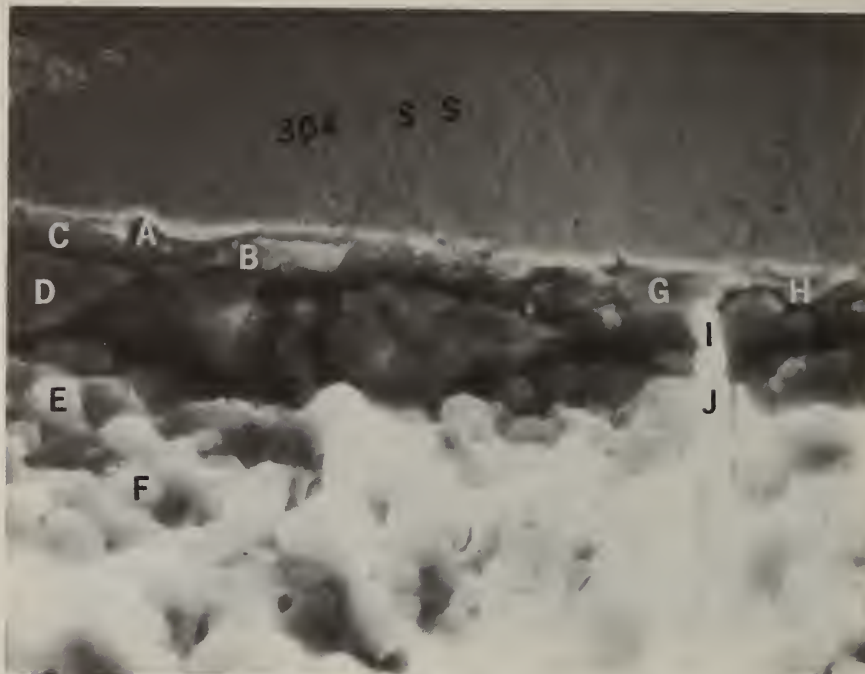
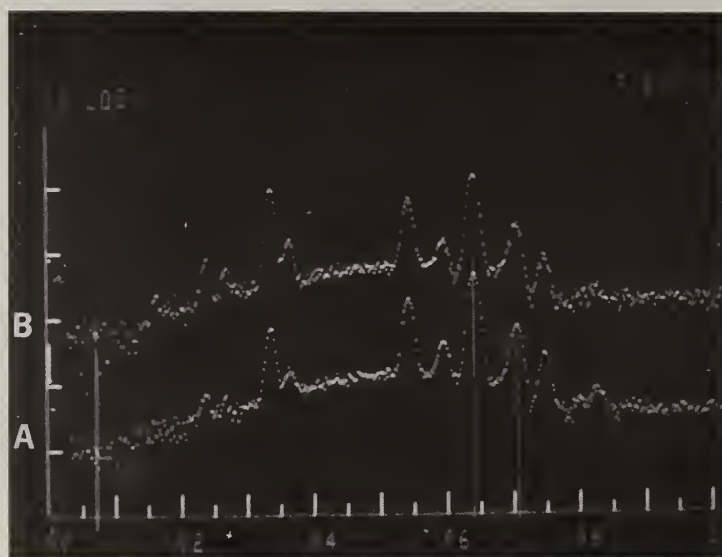
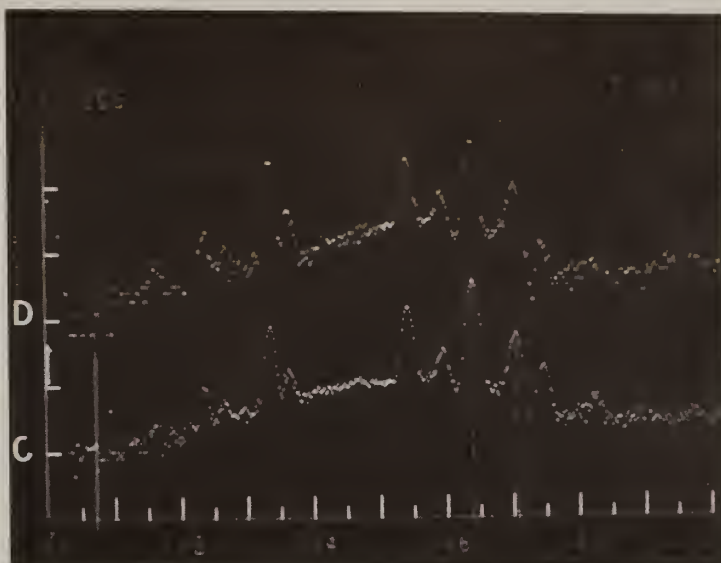
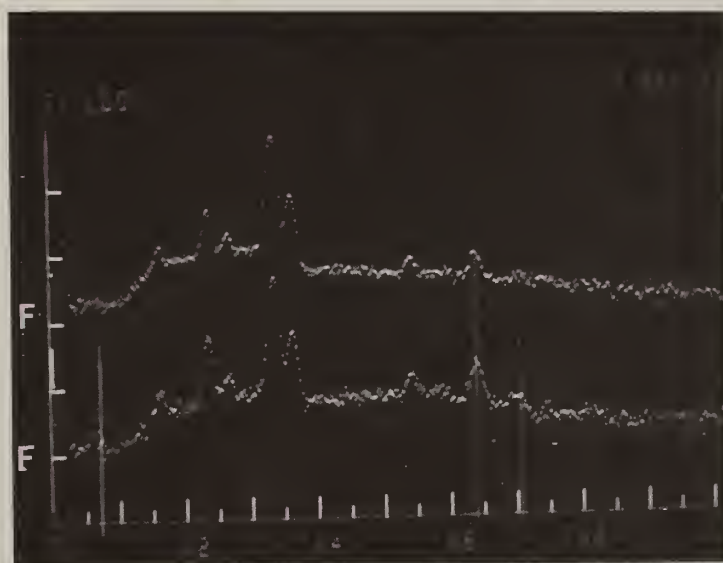
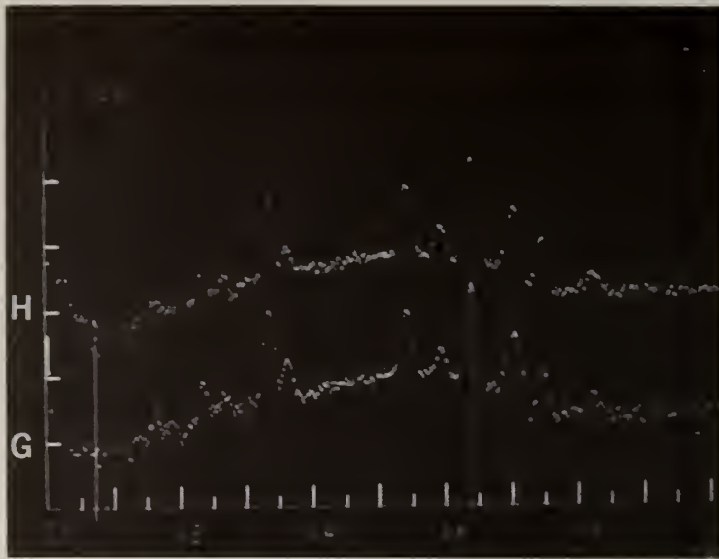
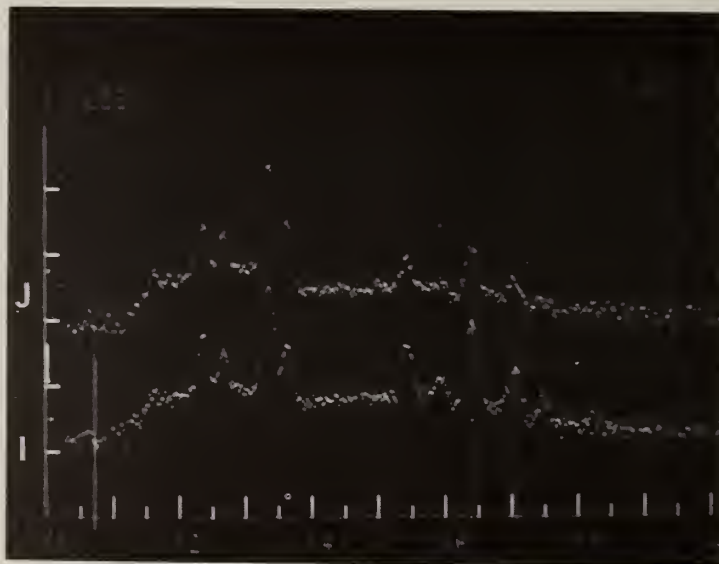
Fig. 9. SEM micrograph, 2000 X, of stainless steel-salt deposit reaction zone. Lettered regions correspond to labeled EDX spectra Figs. 9a-9e. Specimen temperature 400°C; gas stream oxygen rich.

Fig. 9a. EDX spectra of regions A and B of Fig. 9 showing areas of low Ni concentration on the stainless steel interface.

Fig. 9b. EDX spectra of regions C and D of Fig. 9 showing areas of low Ni concentration on the stainless steel interface.

Fig. 9c. EDX spectra of regions E and F of Fig. 9 indicating Fe penetration into the salt deposit.

Fig. 9d. EDX spectra of regions G and H of Fig. 9 showing areas of low Ni concentration on the stainless steel interface.

Fig. 9e. EDX spectra of regions I and J of Fig. 9 indicating Fe and Cr penetration into the salt deposit.

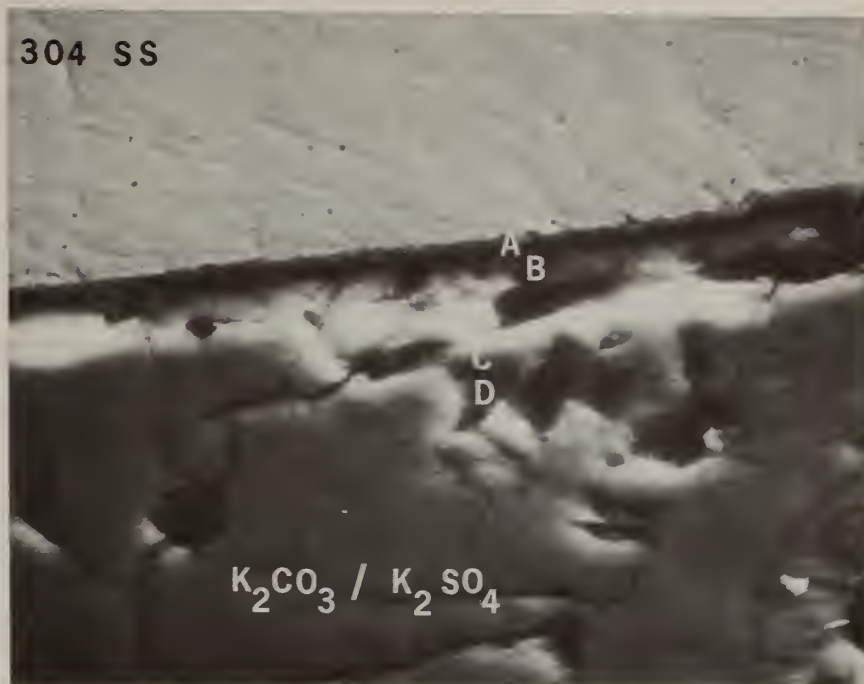
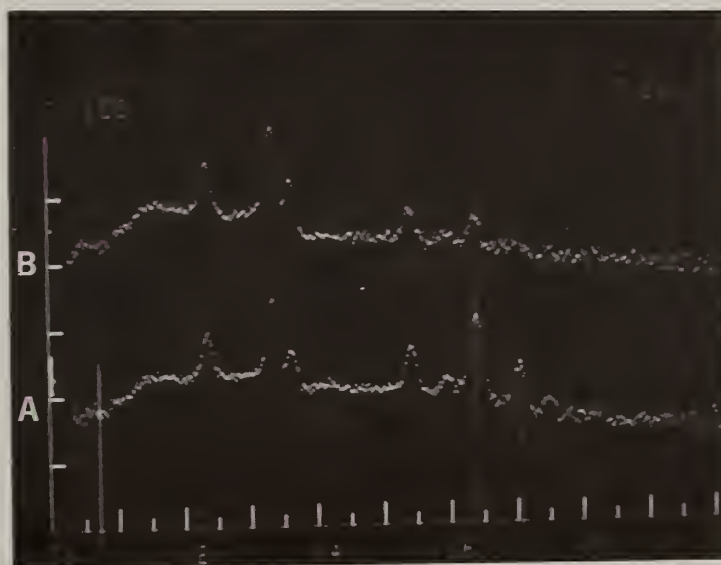
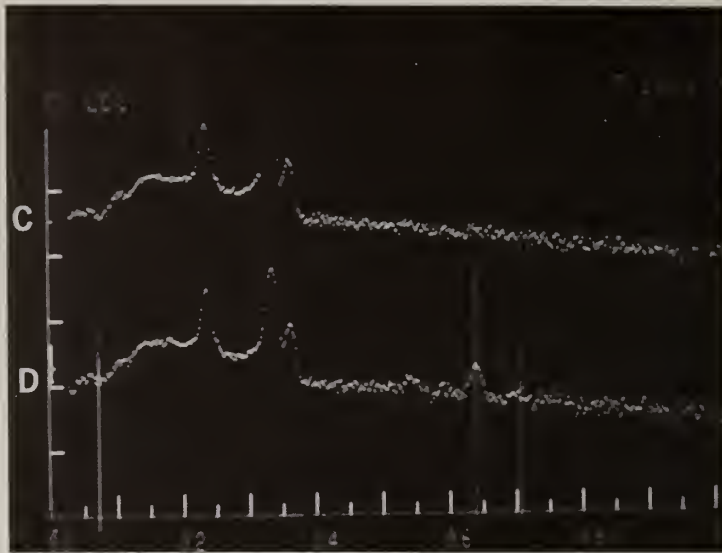
Fig. 10. SEM micrograph, 2000 X, of stainless steel-salt deposit reaction zone. Lettered regions correspond to labeled EDX spectra Figs. 10a and 10b. Specimen temperature 400°C; gas stream oxygen rich.

Fig. 10a. EDX spectra of regions A and B of Fig. 10 showing areas of Fe and Cr penetration into an area of potassium and sulfur.

Fig. 10b. EDX spectra of regions C and D of Fig. 10 showing farther penetration of Fe and Cr into the salt deposit region.

SEM/EDX analysis seems to indicate that preferential leaching of the metal cations from the bulk material (304 stainless steel) is found in a somewhat orderly fashion. The analysis shows that, moving from the stainless steel bulk material to the salt deposit, a high chrome concentration area is found along the edge of the tube and below the surface of the tube top. Areas of high nickel concentration are found within the high chrome concentration matrix while areas of high iron concentration are found next to the salt. Figures 9a-9f show that the iron is found in areas of high potassium concentration a good distance away from the reaction interface region of the stainless steel/salt deposit. Figures 10a-10c again show iron well away from the reaction zone.

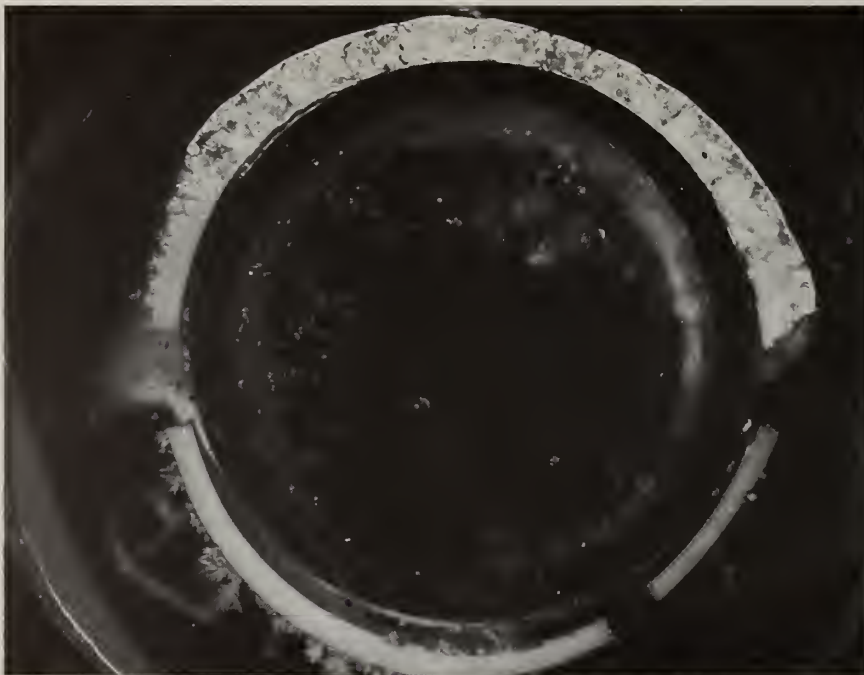
Fig. 11. Section of Type 304 stainless steel tubing after exposure to K_2CO_3/K_2SO_4 seeded fuel rich hot gas stream. Note formation of 0.8 mm deposit on upper surface. Tube temperature 400°C . 6 X.

In a fuel rich hot gas stream, a thin, 0.6 to 0.8 mm, as compared to the oxygen rich environment, salt deposit was formed. As noted in the oxygen rich series these samples also exhibited decreasing thickness with increasing temperature. In contrast to the oxygen rich specimen the fume deposit, 0.4 to 0.7 mm (the layer on the under side of the tube), was heavier. However, it also decreased with temperature, Figures 11, 12 and 13.

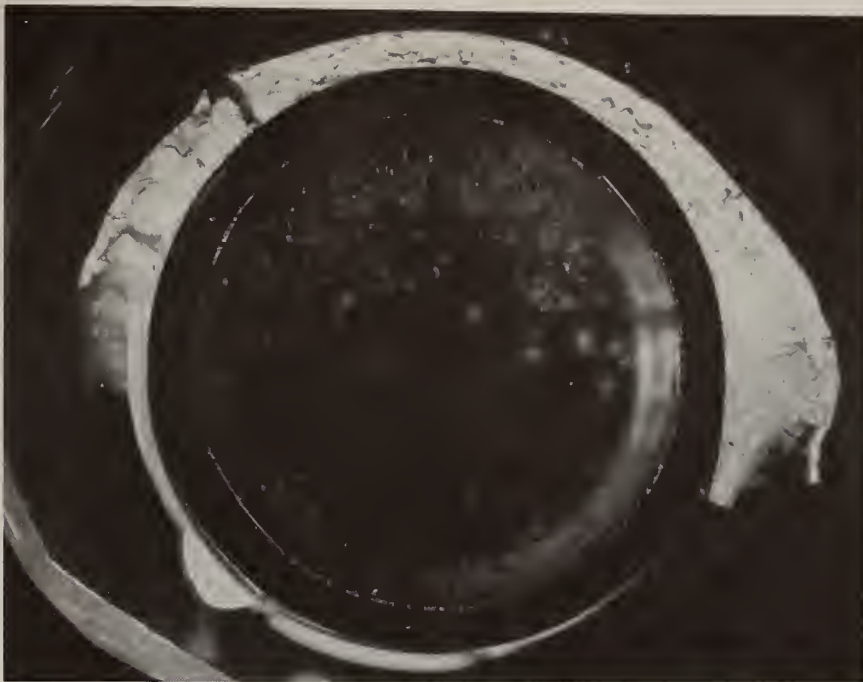
Fig. 12. Section of Type 304 stainless steel tubing after exposure to K_2CO_3/K_2SO_4 seeded fuel rich hot gas stream. Tube temperature $500^\circ C$. 6 X.

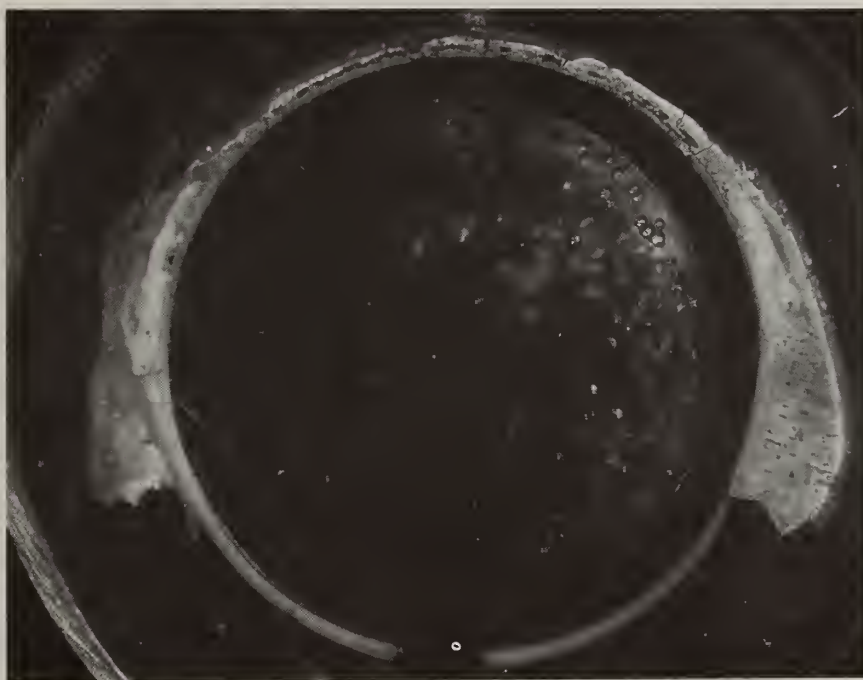
Fig. 13. Section of Type 304 stainless steel tubing after exposure to K_2CO_3/K_2SO_4 seeded fuel rich hot gas stream. Note formation of thin deposit on upper surface. Tube temperature $590^\circ C$. 6 X.

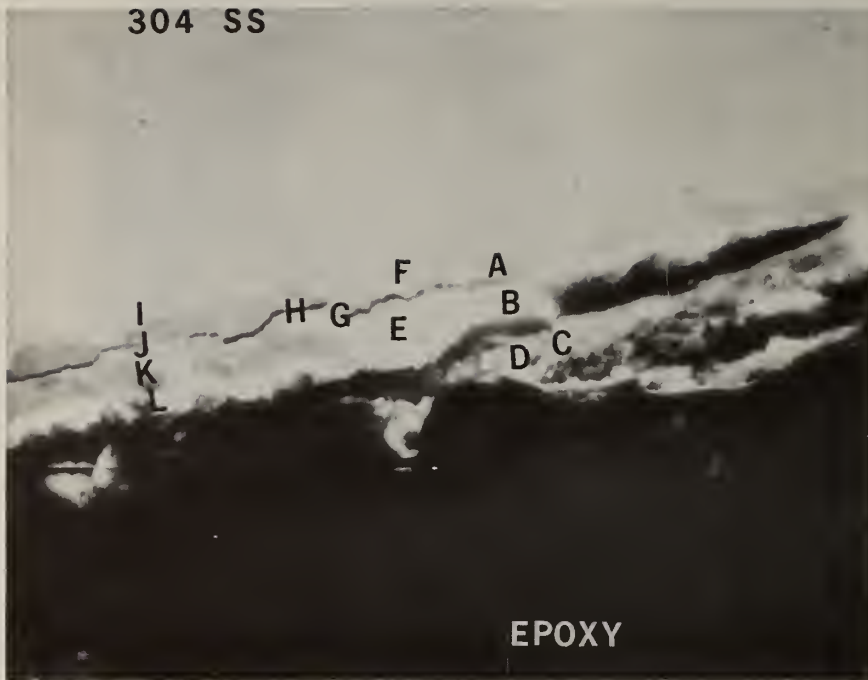
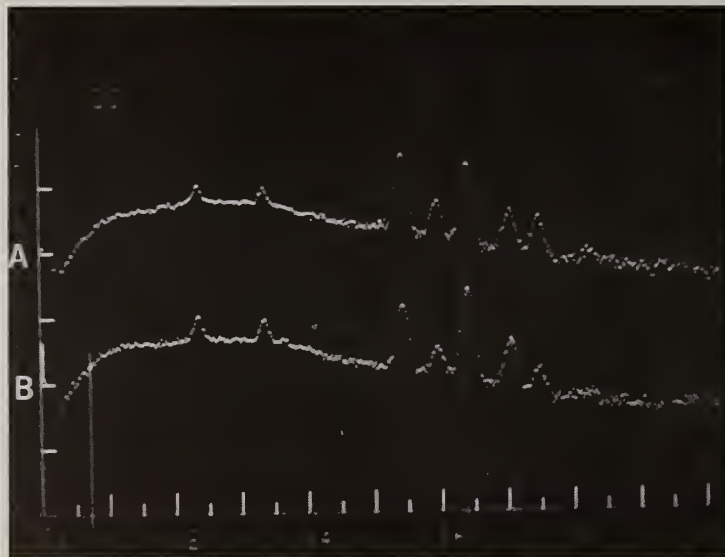
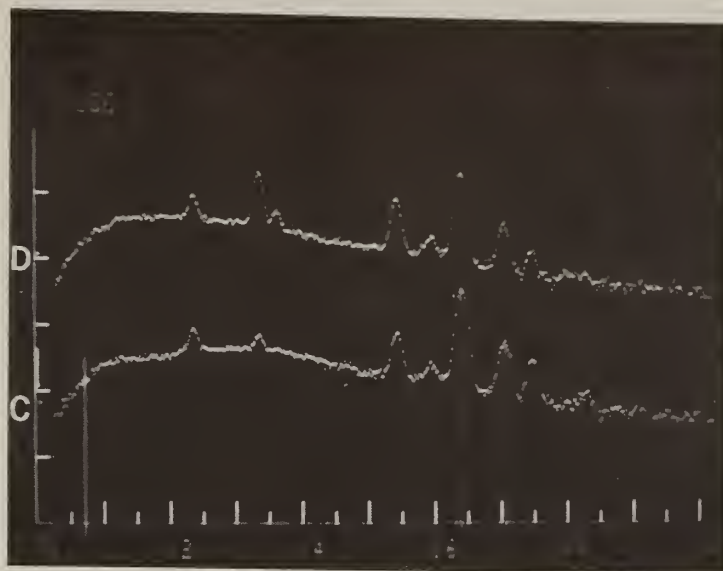
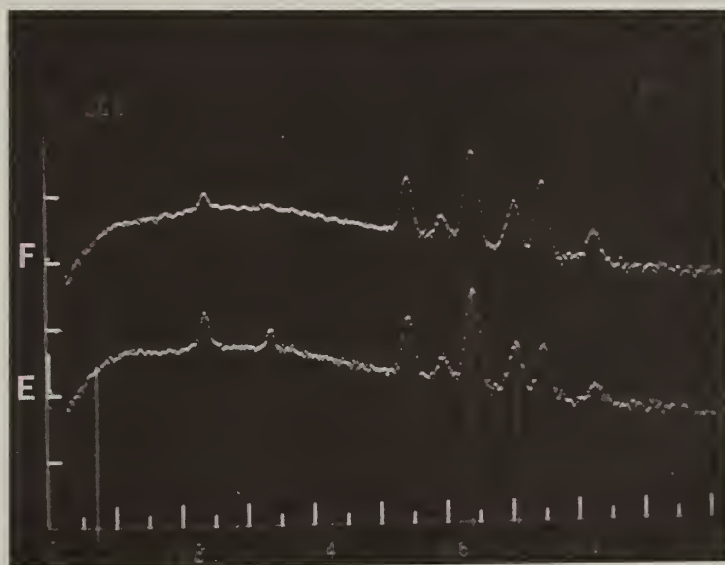
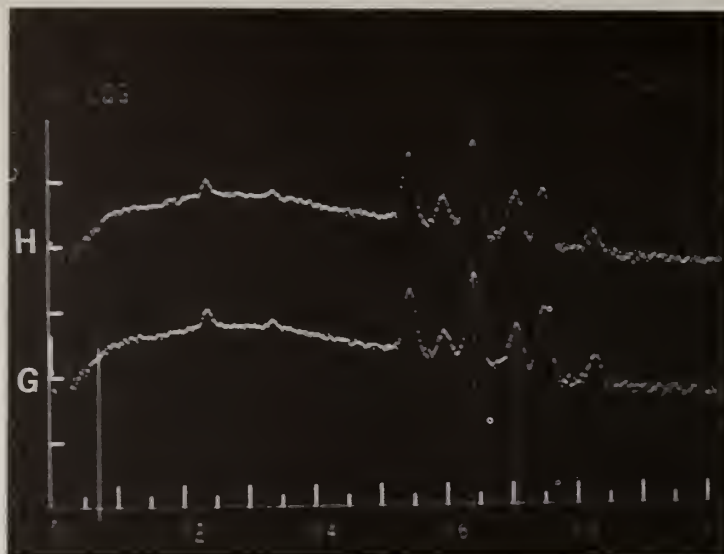
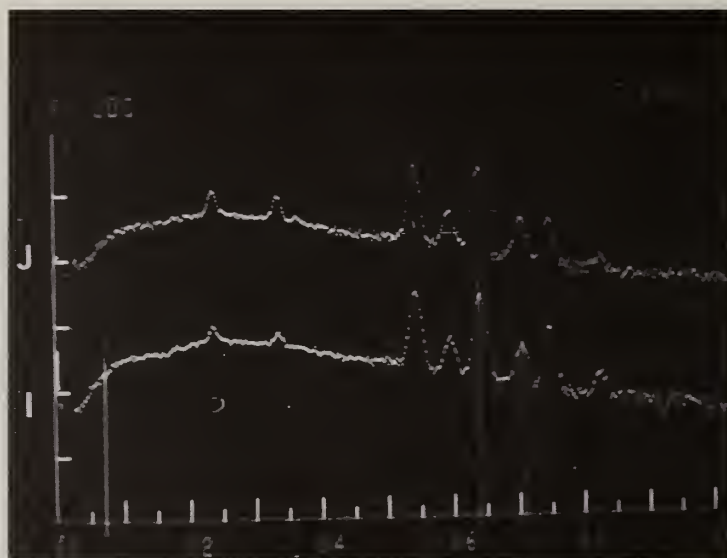
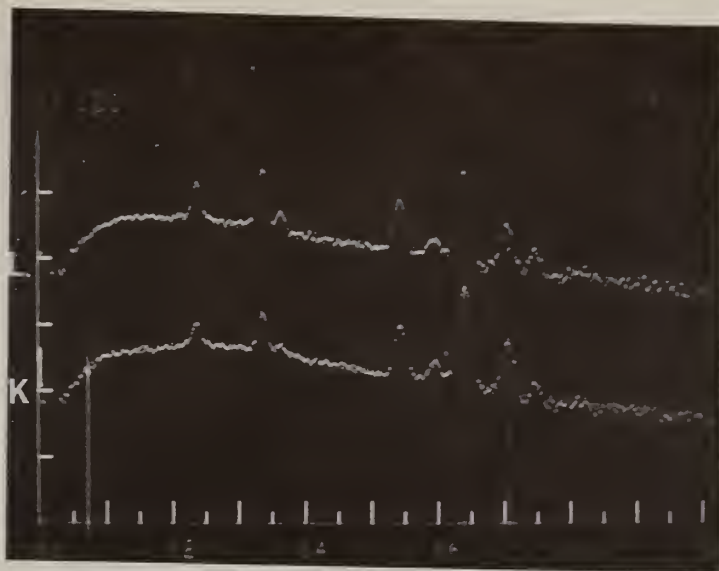
Fig. 14. SEM micrograph, 2000 X, of stainless steel-salt deposit reaction zone. Lettered regions correspond to labeled EDX spectra, Figs. 14a to 14f. Specimen temperature 500°C; gas stream fuel rich.

Fig. 14a. EDX spectra of regions A and B of Fig. 14 pointing out areas of high Cr concentration and low Ni concentration on the stainless steel interface.

Fig. 14b. EDX spectra of regions C and D of Fig. 14 indicating areas of low Cr and low Ni concentration at the stainless steel interface.

Fig. 14c. EDX spectra of regions E and F of Fig. 14 showing areas of high Ni and low Cr concentration at the stainless steel interface.

Fig. 14d. EDX spectra of regions G and H of Fig. 14 showing areas adjacent to E and F of high Ni concentration and low Cr concentration.

Fig. 14e. EDX spectra of regions I and J of Fig. 14 showing areas of high Ni and high Cr concentration at the interface.

Fig. 14f. EDX spectra of regions K and L of Fig. 14 of areas below I and J showing low Cr and low Ni concentration.

As in the oxygen rich test samples the fuel rich samples also exhibited reaction zone areas. Again, these areas showed increased activity in corrosion with increased sample temperature. Figure 14, specimen temperature 500 °C and Figure 15, specimen temperature 590 °C show areas of corrosion at the stainless steel/salt interface with areas of high metal cation concentration. However, the reaction areas do not seem to be as great under the fuel rich conditions as compared to the oxygen rich conditions.

As noted by SEM/EDX analysis, Figures 14a-14g and Figures 15a-15g, the edge of the stainless steel bulk material contains regions of high chrome concentration followed by areas of high nickel concentration. Areas of high iron concentration are found next, with iron and potassium in the salt deposit adjacent to the stainless steel. The salt deposit seems to contain more sulfur than in the oxygen rich cases, but both have a crust of potassium and sulfur in high concentration on the top of the salt layer.

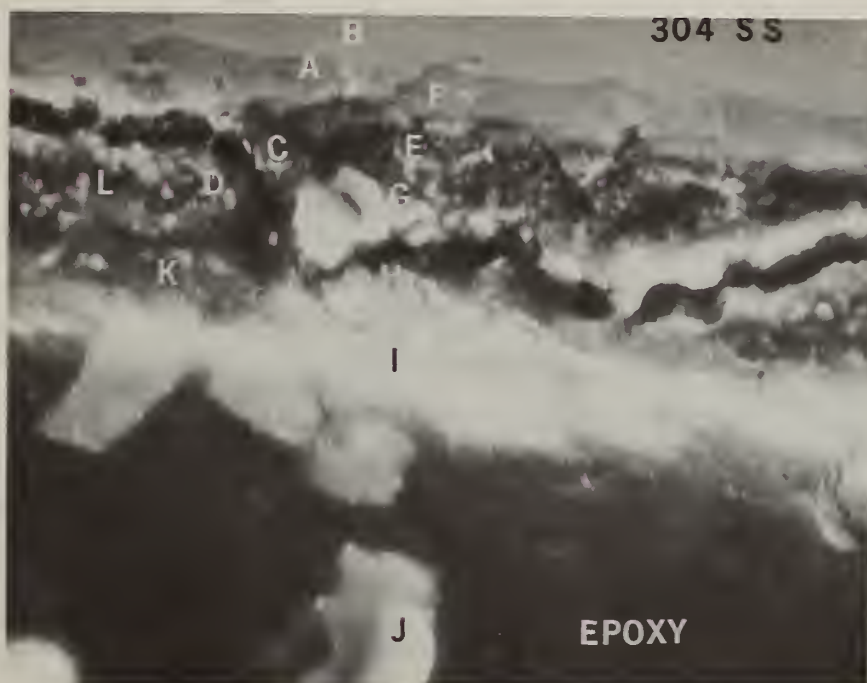
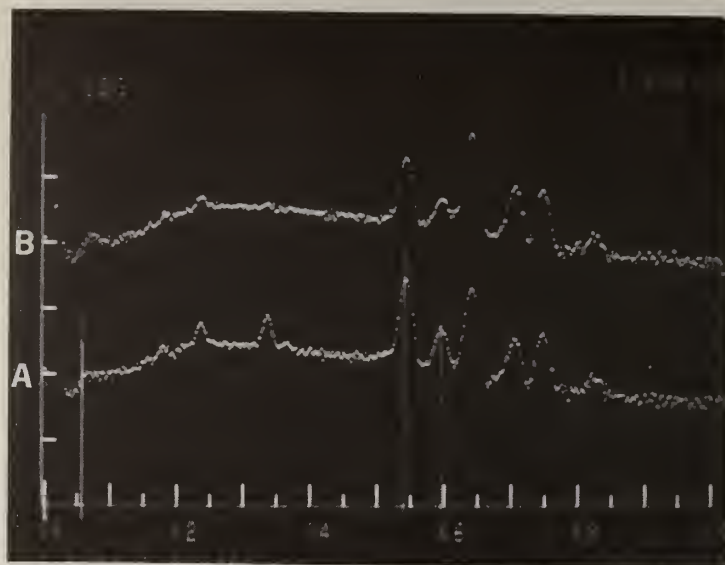
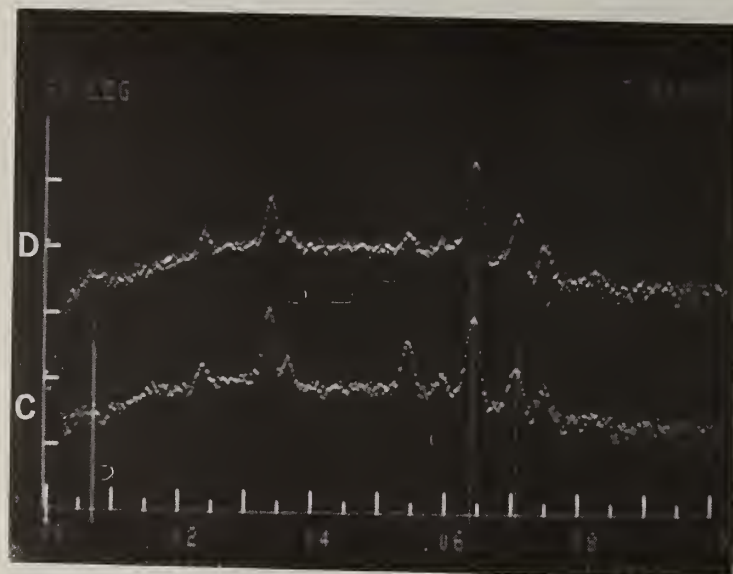
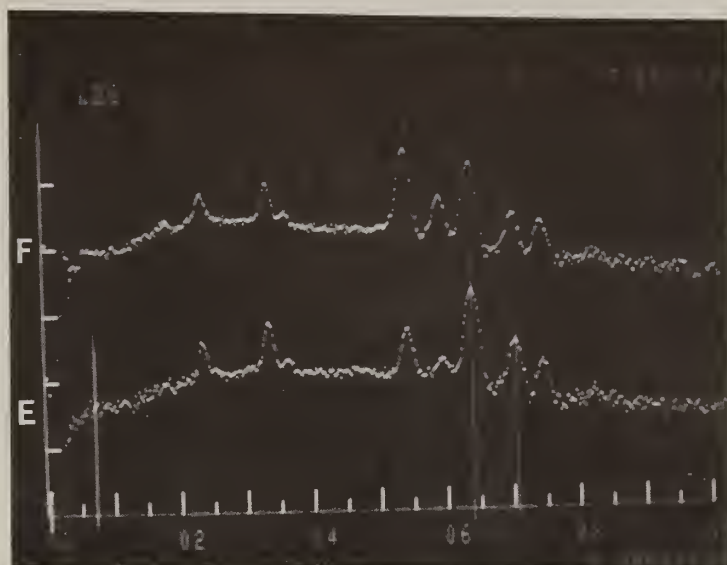
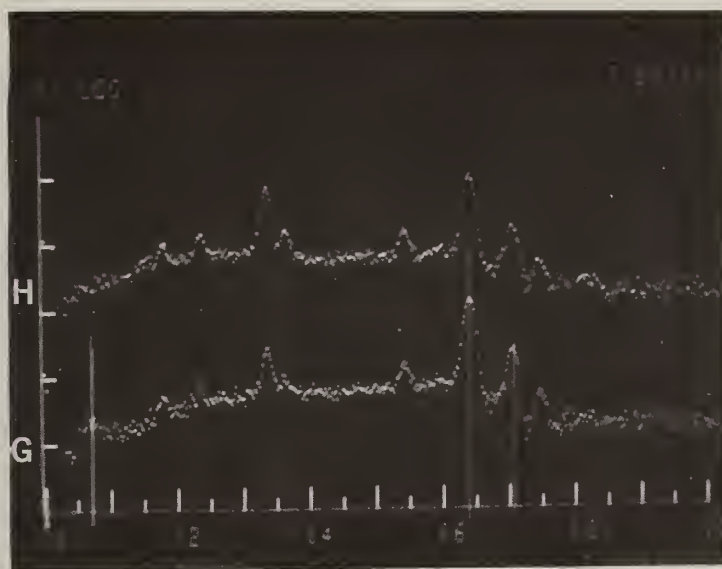
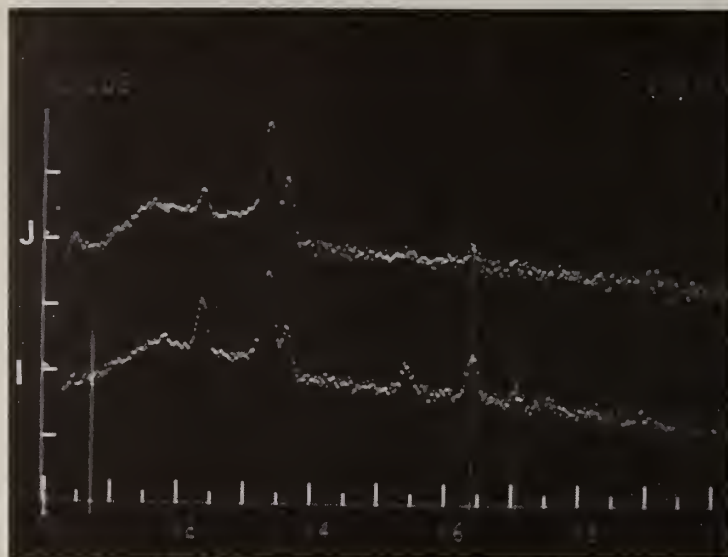
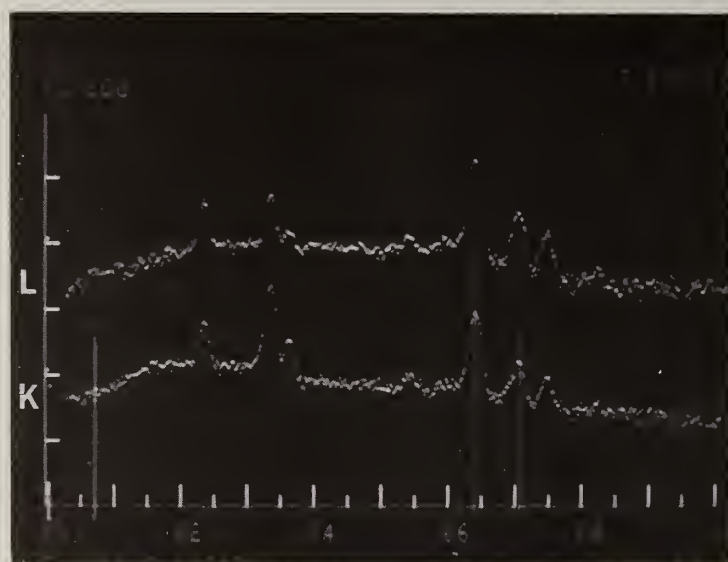
Fig. 15. SEM micrograph 2000 X, of stainless steel-salt deposit reaction zone. Lettered regions correspond to labeled EDX spectra, Figs. 15a to 15f. Specimen temperature 590°C gas stream fuel rich.

Fig. 15a. EDX spectra of regions A and B of Fig. 15 showing area of high Cr and high Ni concentration as compared to bulk stainless steel.

Fig. 15b. EDX spectra of regions C and D of Fig. 15 showing areas of high Fe, low Ni and low Cr concentration at the stainless steel-salt interface.

Fig. 15c. EDX spectra of region E of Fig. 15 indicating area of high Cr concentration with Ni and region F of Fig. 15 showing area of low Cr concentration with high Ni concentration.

Fig. 15d. EDX spectra of regions G and H of Fig. 15 showing areas of high Fe and low Ni and low Cr concentrations at the stainless steel-deposit interface.

Fig. 15e. EDX spectra of regions I and J of Fig. 15 showing Fe and Cr penetration into the salt deposit.

Fig. 15f. EDX spectra of regions K and L of Fig. 15 showing areas of high Ni and low Cr concentration at the stainless steel-salt interface.

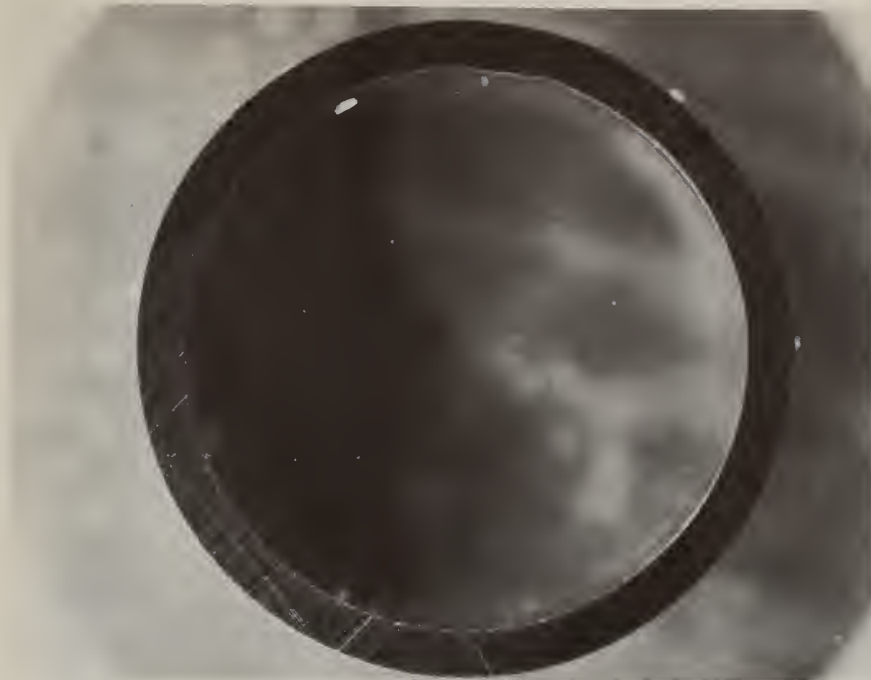
Fig. 16. Section of Type 304 stainless steel prior to exposure to the seeded hot gas stream. 6 X.

Stainless Steel Reference Specimen - As with most analytical techniques, reference samples are used to check some stage of the analysis. At the present time a randomly selected sample type 304 stainless steel that has been cleaned, cut and polished has been used to check outer edges or surfaces for areas where corrosion would most likely occur. A general overview of the tube (Figure 16) would seem to indicate that the 304 stainless is very clean and uniform on the outer edges. However, Figures 17 and 18, shows that in the manufacturing, rough surfaces, i.e., holes and pit areas, can occur. These areas would be more susceptible to a corrosion process and promote deterioration of the surface under hot plasma and seeding conditions. Therefore, not all areas analyzed for pits and holes are necessarily due to the corrosion process. EDX analysis shows that traces of sulfur are already present in the matrix. No other inconsistencies such as areas of high chrome concentration or high iron concentration are found in the metal, but rather a uniform distribution of chrome, iron and nickel is found throughout the 304 stainless steel.

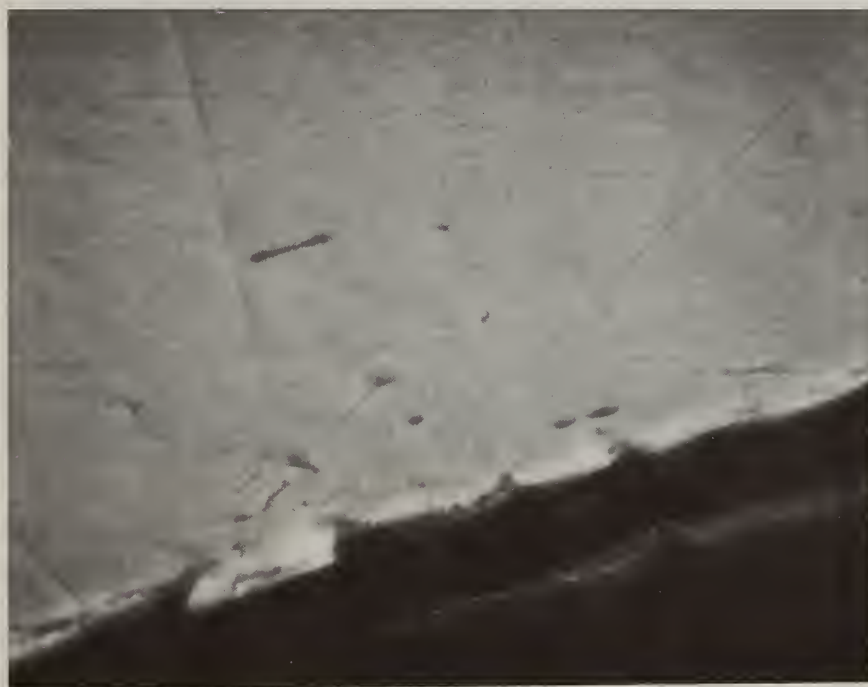
Fig. 17. SEM micrograph 4500 X, of section of Fig. 16 showing stainless steel edge.

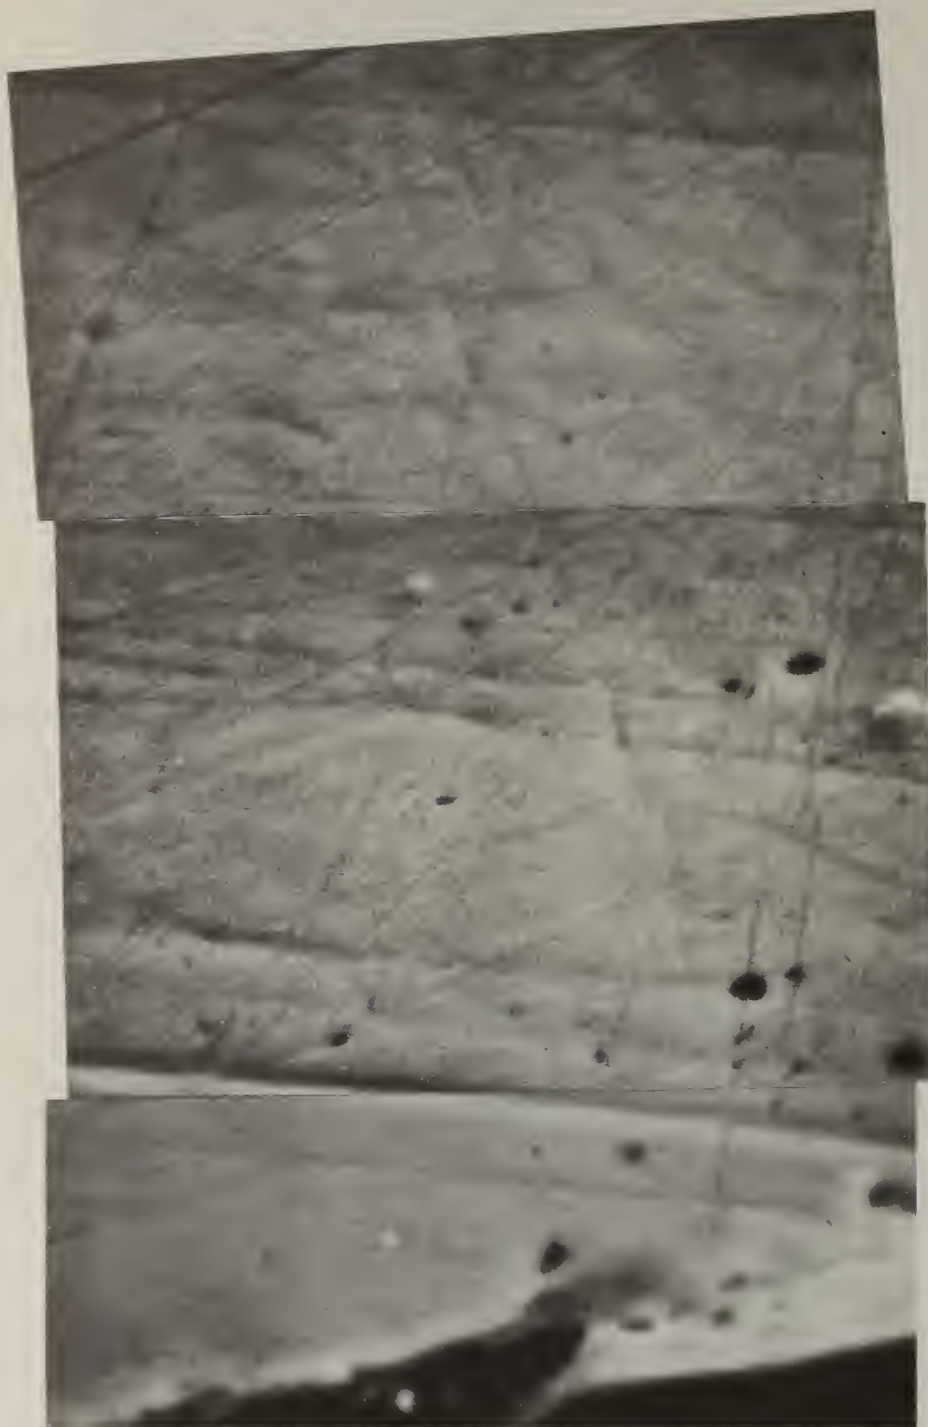
Fig. 18. SEM micrograph (montage) 9000 X, of a section of Fig. 16 showing inclusions and pits in the stainless steel.
